**RESERVE FUND STUDY
THE LANDING
PETERBOROUGH STANDARD CONDOMINIUM CORPORATION NO: 75
1579 Anstruther Lake Road, Apsley, Ontario**

PROJECT NO: 21-007

February 28, 2022

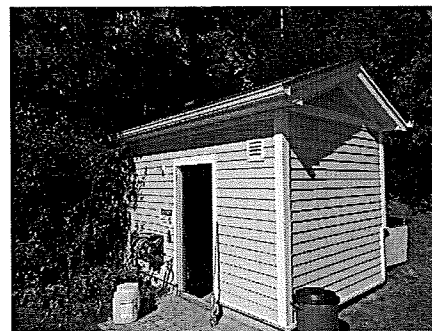
Photo 2: Water treatment shed.

- 2.3.1.2 The storage building, water treatment shed, satellite service shed and gazebo are all wood framed structures. Based on my visual review these structures are in excellent condition. The life of these wood structures will exceed the thirty year life span of this report.

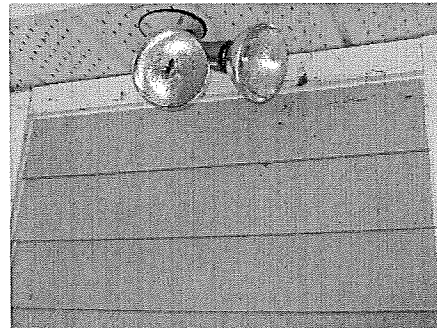
2.3.3.2 The painted wood siding and trim on the storage building, water treatment building and satellite shed is in excellent condition and with regular maintenance should provide a service life beyond the scope of this study. An allowance for localized repair and painting is included in the reserve fund budget.

Photo 3: Painted wood siding and trim on storage building.

Siding and trim allowance: \$3,000 Time remaining: 10 yr. Life cycle: 10 yr.

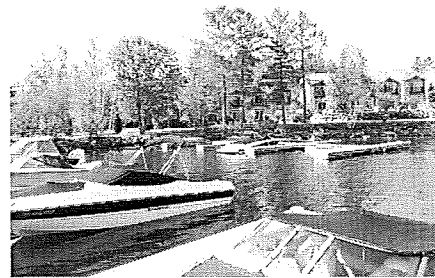
2.3.5.5 The original boat dock structures were pressure treated wood decking on extruded polystyrene floatation blocks. The floatation blocks on the original sections of docks were water logged and damaged by wildlife. Dock replacement with aluminum, pressure treated lumber and poly tank floatation units was started in 2021. An allowance for completion of the dock replacement has been included in 6 years along with subsequent replacement in 25 and 27 years.

Photo 4: Boat docks.

Boat dock replacement: \$70,000 Time Remaining: 6 yr.
Boat dock replacement: \$30,000 Time Remaining: 25 yr. Life Cycle: 25 yr.

Boat dock replacement: \$50,000 Time Remaining: 27 yr. Life Cycle: 25 yr.

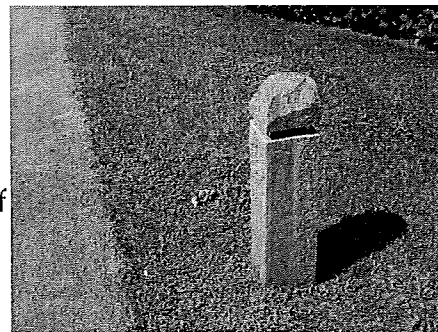
The site lighting consists of light standards, wall mounted fixtures and . The lighting appears to be in good working order. Regular maintenance of the lighting will allow the existing lighting to provide continued service. Site lighting replacement has been budgeted.

Photo 5: Site lighting.

Site lighting replacement: \$5,000 Time Remaining: 11 yr. Life Cycle: 25 yr.
