The Landing – 1579 Anstruther Lake Road, Apsley - Class 1 Reserve Fund Study

May 23, 2024

Prepared for:
Peterborough Standard Condominium
Corporation No. 75

Cambium Reference: 19959-001

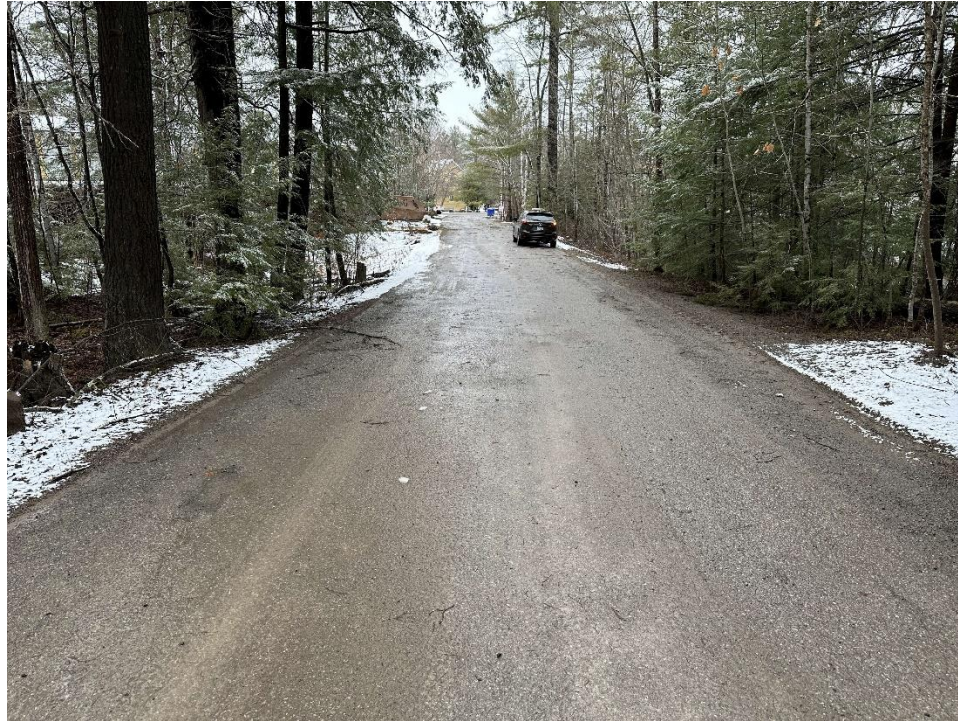
Photo 1 Entrance Roadway Overview

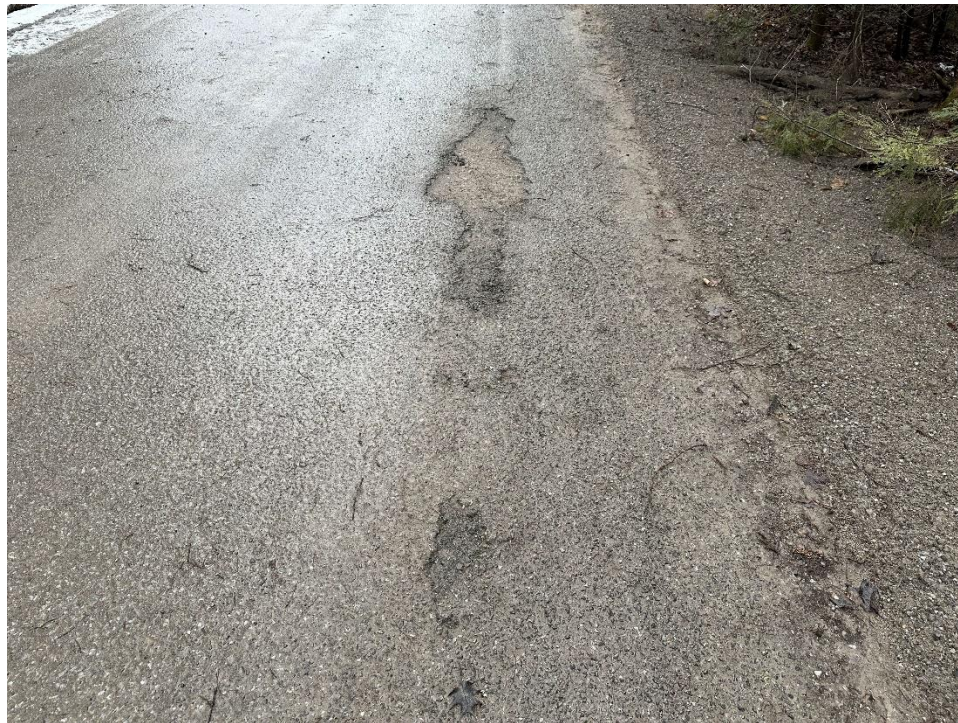
The asphalt paving at the entrance roadway has closely-spaced cracks and localized potholes. Local repairs are expected to be required in the next several years, followed by mill and overlay replacement later in the report term.

Photo 2 Localized Potholes on Main Roadway

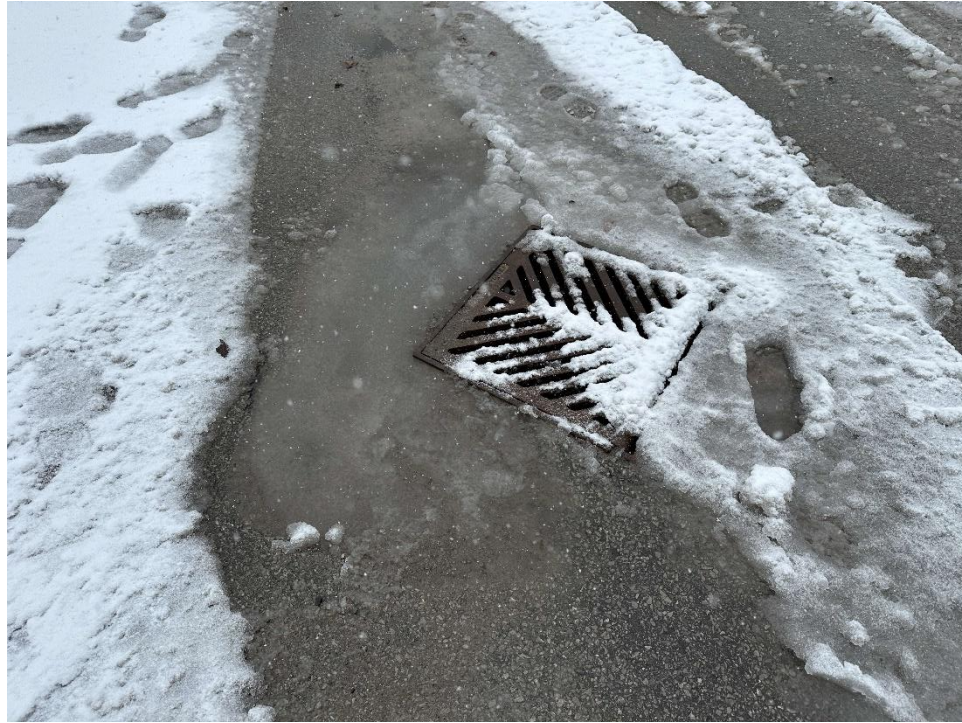
Photo 3 Localized Asphalt Settlement at Catch Basin

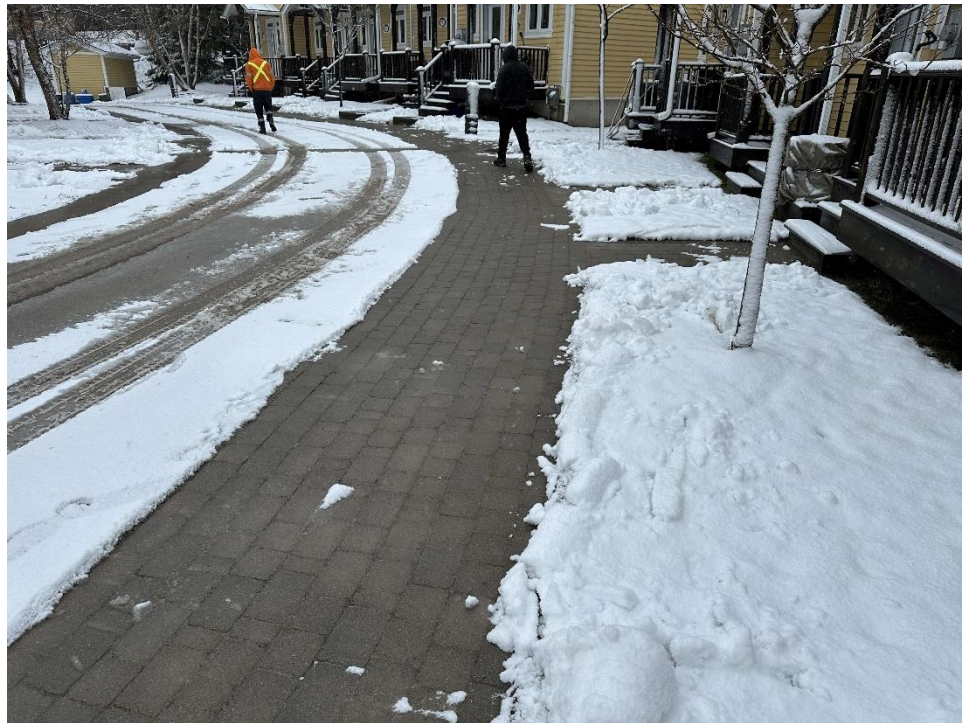
The unit paver walkways are generally in good condition. Budgets are included for levelling walkways and local replacements of unit pavers later in the report term.

Photo 4 Interlock Stone Walkway Overview

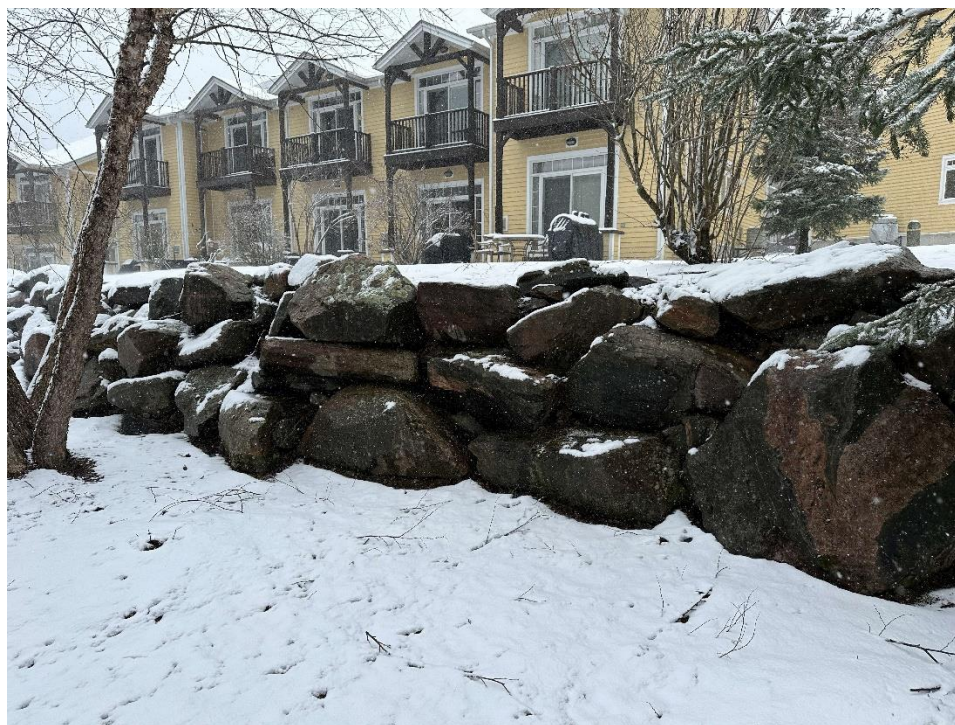
Photo 6 Typical Retaining Wall

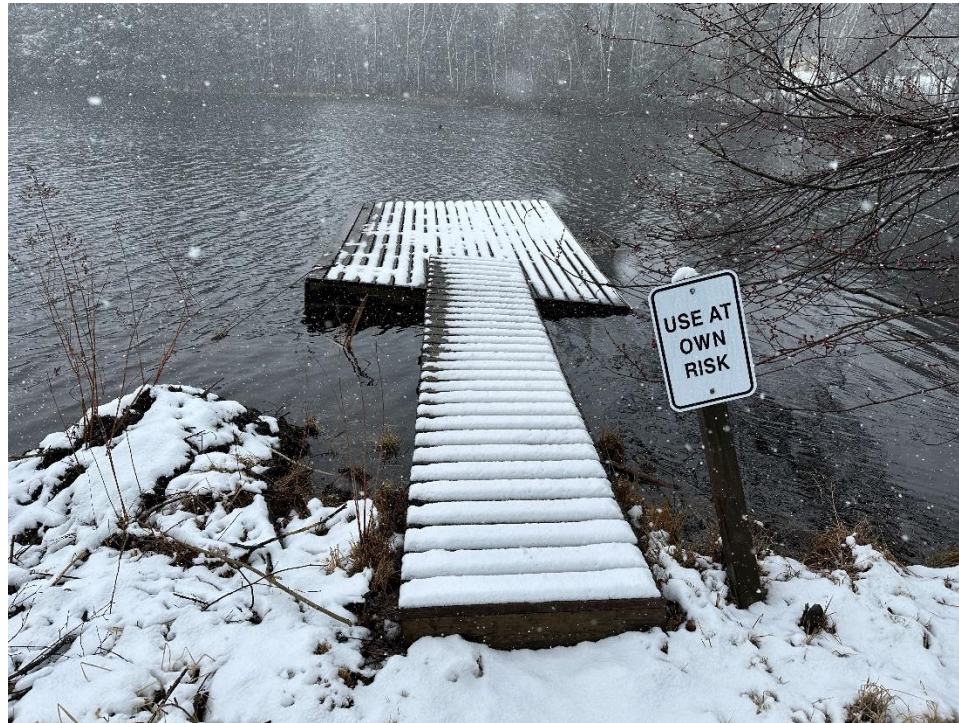
Photo 7 Typical Wood Dock

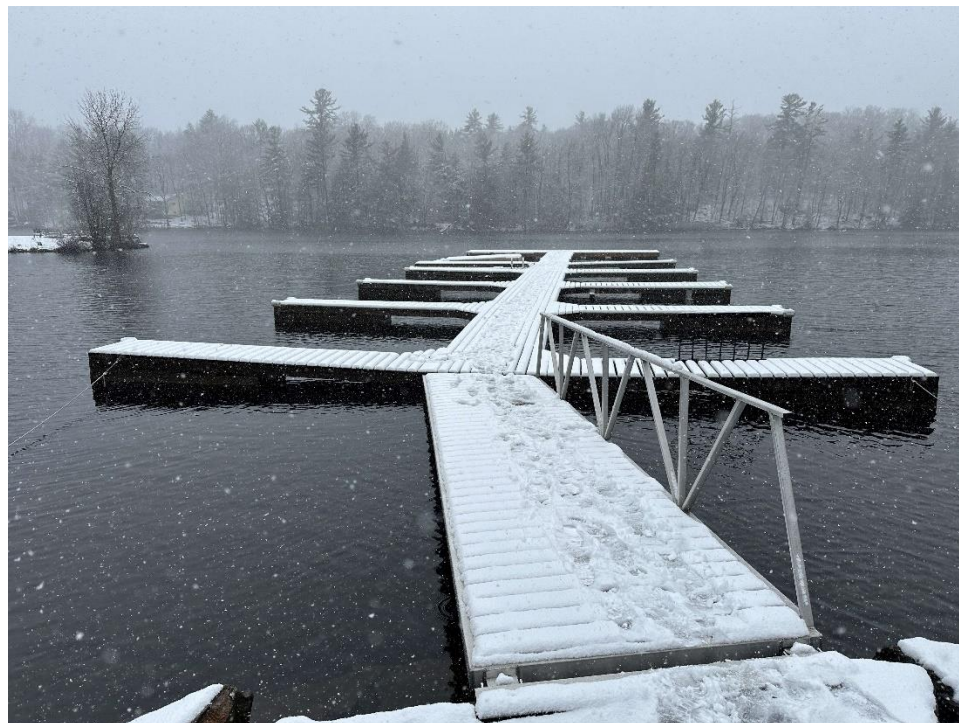
A portion of the boat docks were replaced in 2021. We understand that the remaining docks will be replaced between 2027 and 2029. Budgets for replacement are included.

Photo 8 Typical Boat Docks (Wood and Aluminum Frame)

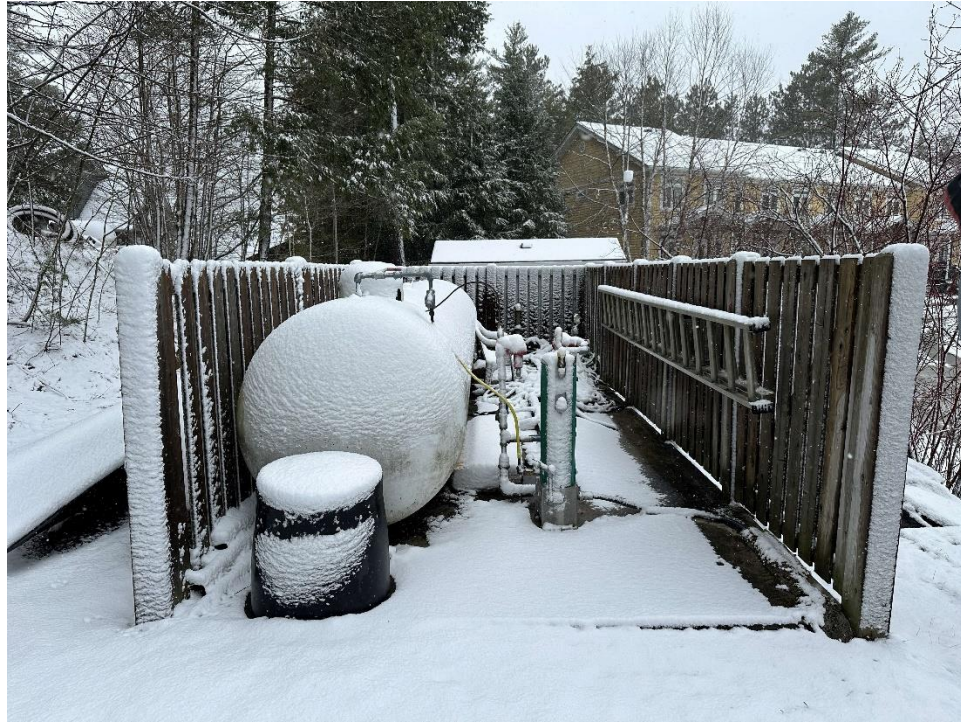
The wood fencing at the propane tank is in serviceable condition. We expect sections can be repaired as part of regular maintenance. A full replacement budget is included later in the report term.

Photo 15 Propane Tank (outside of scope) and Wood Fencing

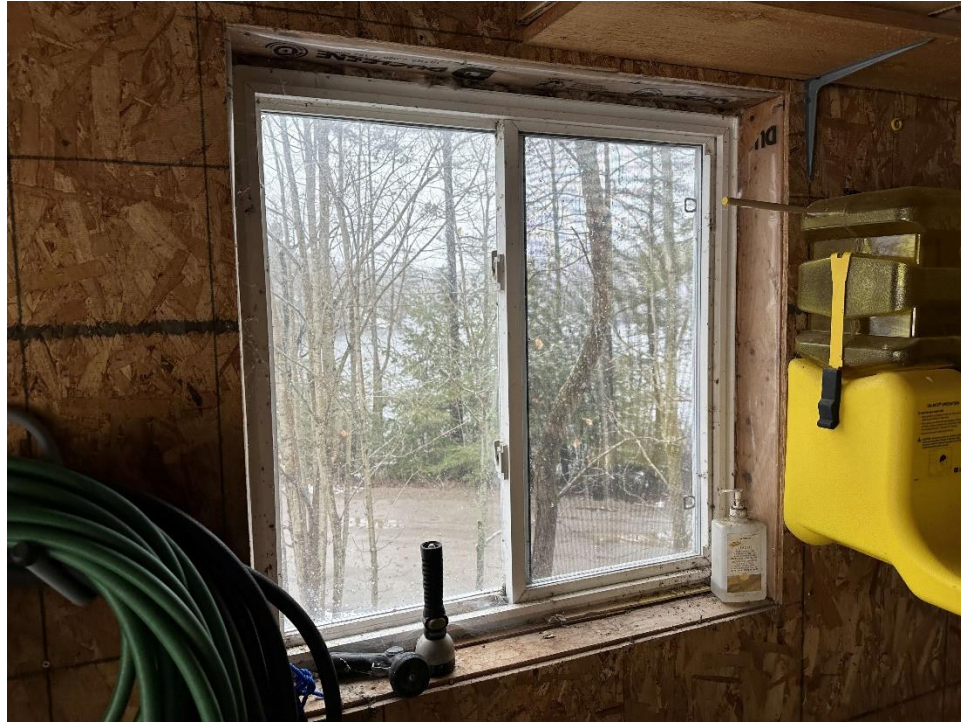
There is one window at the Storage Building. We expect the window will be replaced as needed, as part of regular maintenance.

Photo 17 Operable window at Storage Building

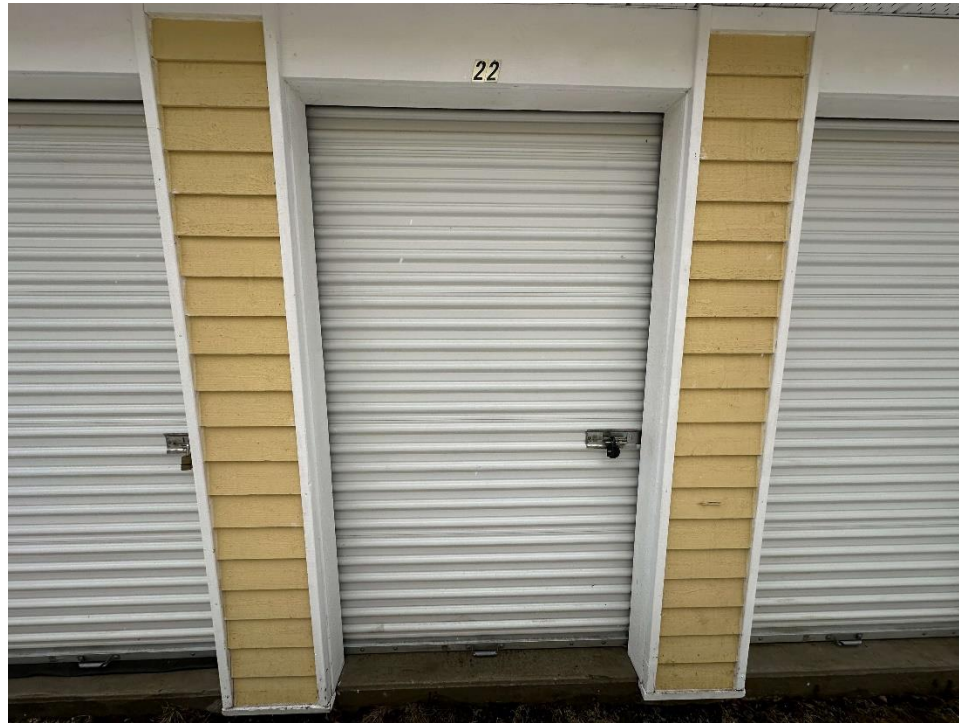
End of service life budgets have been included for replacement of exterior doors for the outbuildings. A replacement budget is included for one (1) metal rolling overhead door at the Storage Building. The storage unit doors are the responsibility of the owners.

Photo 19 Metal Rolling Overhead Door at Storage Building

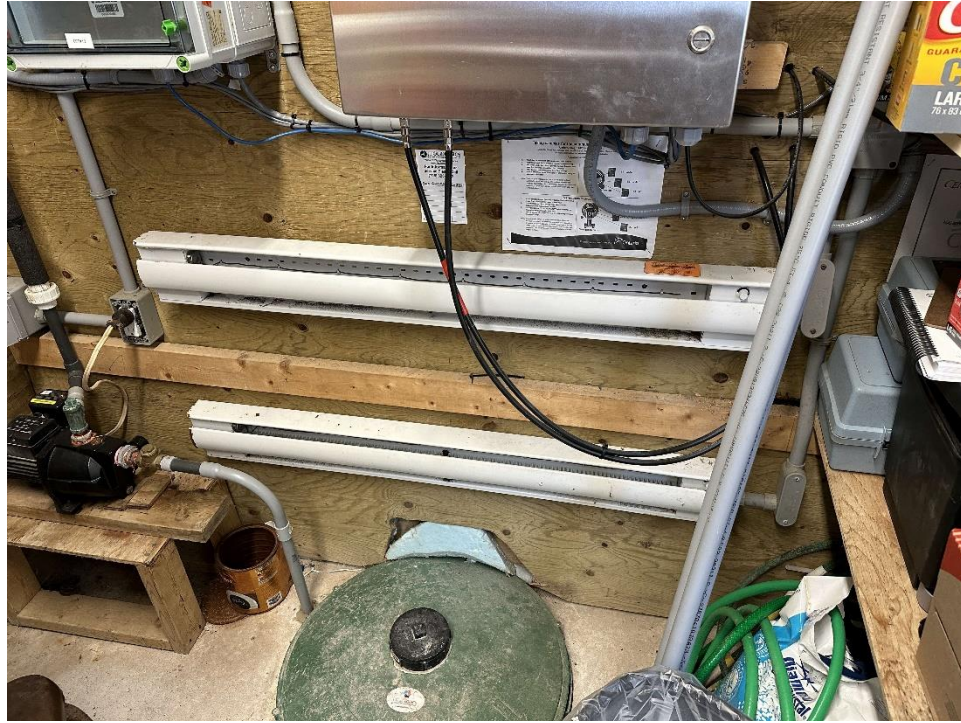
HVAC equipment in the outbuildings is limited to electric baseboard heaters and individual exhaust vents in the outbuildings. Budgets are included for replacement of baseboard heaters. Exhaust vents are expected to be replaced, as needed, as a maintenance expense.

Photo 23 Electric Baseboard Heaters at Pump House

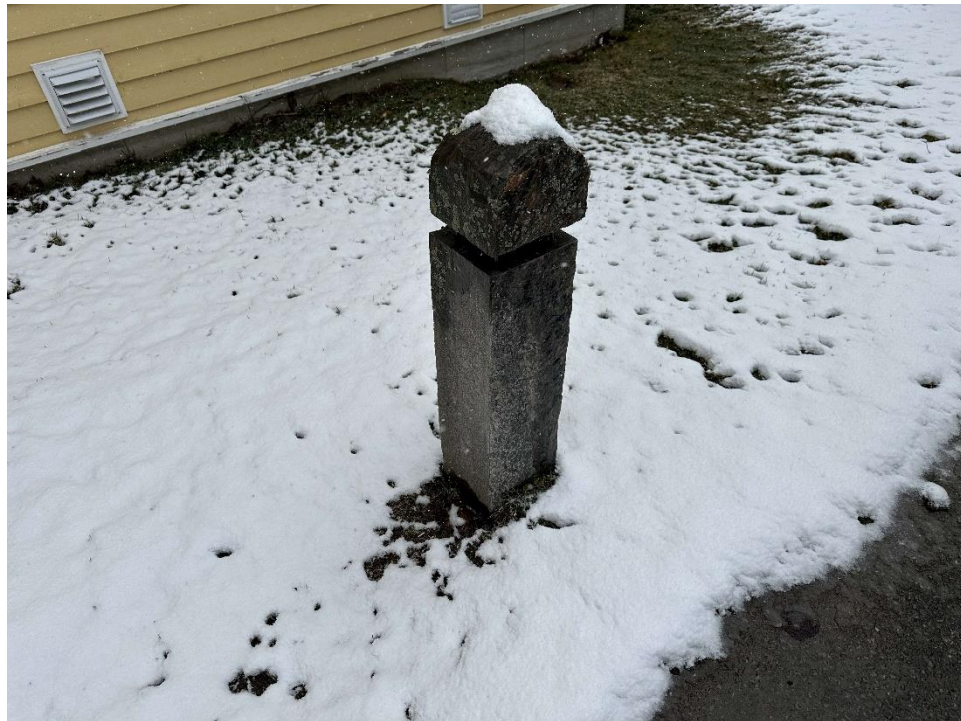
We understand the bollard lights have ongoing issues related to the wiring to light fixtures. A replacement budget is included in the near term.

Photo 28 Concrete Bollard Light at Walkway
